## 2-Stage Drainage Ditch - The Nature Conservancy

October 1, 2007 through September 30, 2010

Prepared By: Richard Biske,

The Nature Conservancy

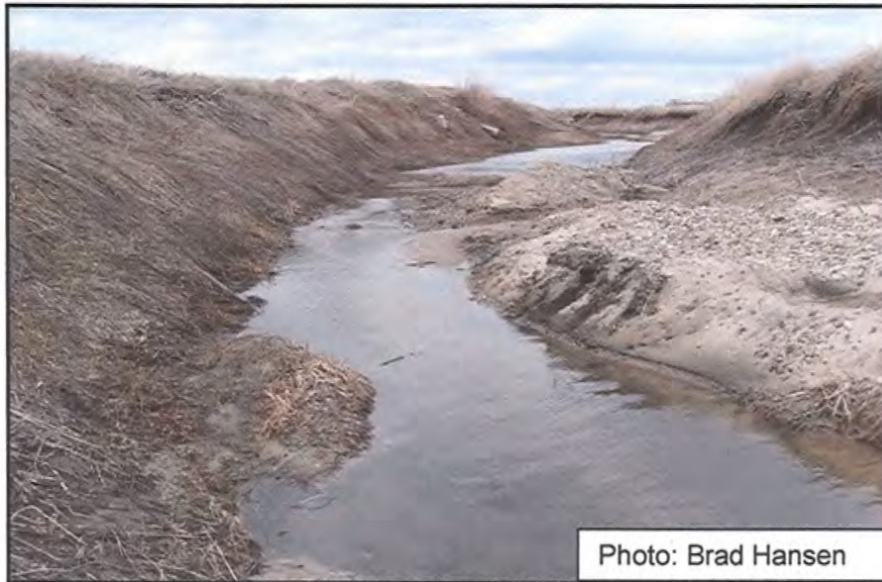
Figure 1. Sedimentation and slumping banks.

Conventional ditches are wide and deep with steep sides that easily erode (Figure 1), impacting the stability of the ditch and contributing to excessive levels of nitrogen and phosphorus in streams and flooding, all of which can damage water quality and aquatic habitat. Once ditches are constructed or channelized, streams attempt to return to their natural course by meandering, resulting in even greater potential for erosion and deposition within the channel (Hansen, et. Al, 2006).

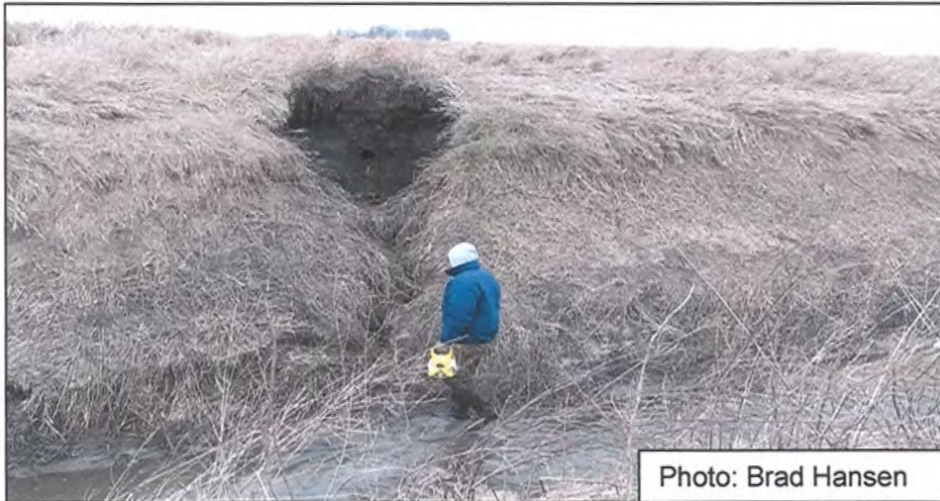
Figure 4. Identifying tile and side inlets.

Site surveys (Figure 4), ditch characteristics and regional hydrology information was used to develop a design by the Board of Water and Soil Resources' (BWSR) Agricultural Engineer with assistance from University of Minnesota Biosystems and Bioproducts Engineering. Please refer to Appendix A for all design sheets. Because the 2-stage ditch is an evaluation project and monitoring is being conducted, additional drainage conservation measures were designed and installed. Within the ditch channel a linear wetland (Figure 4) was designed. This is a narrow channel within the bench of the ditch parallel to the base flow channel. The linear wetland pre-treats tile water for about 30 feet before entering the ditch channel. Each side inlet and tile outlets were also rip rapped to stabilize banks and reduce erosion from these outlet pipes and minimize bank scouring (Figure 6).

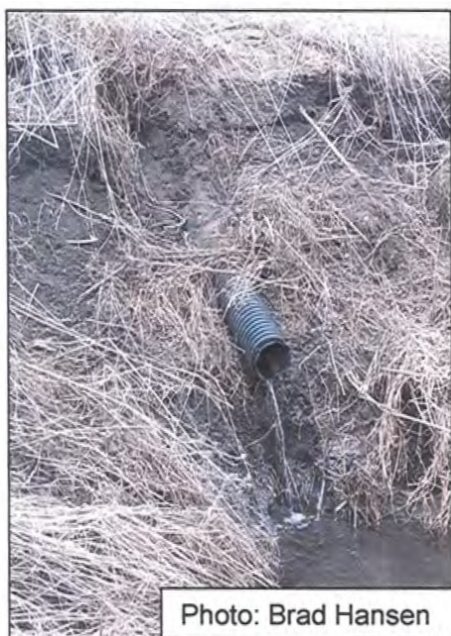
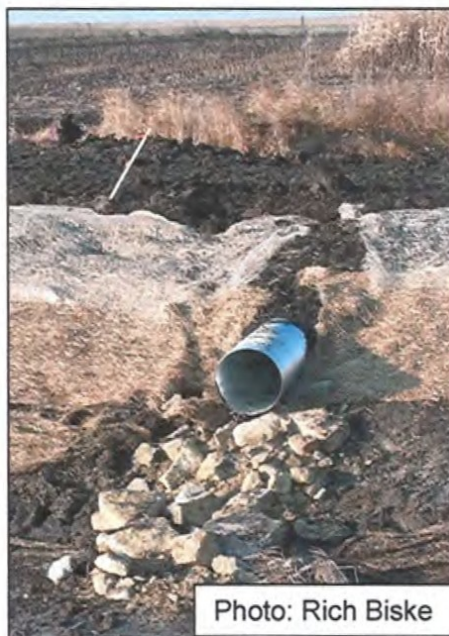
Figure 6. Side inlet modifications.

Tile inlet prior to 2-stage construction

Side inlet post 2-stage construction

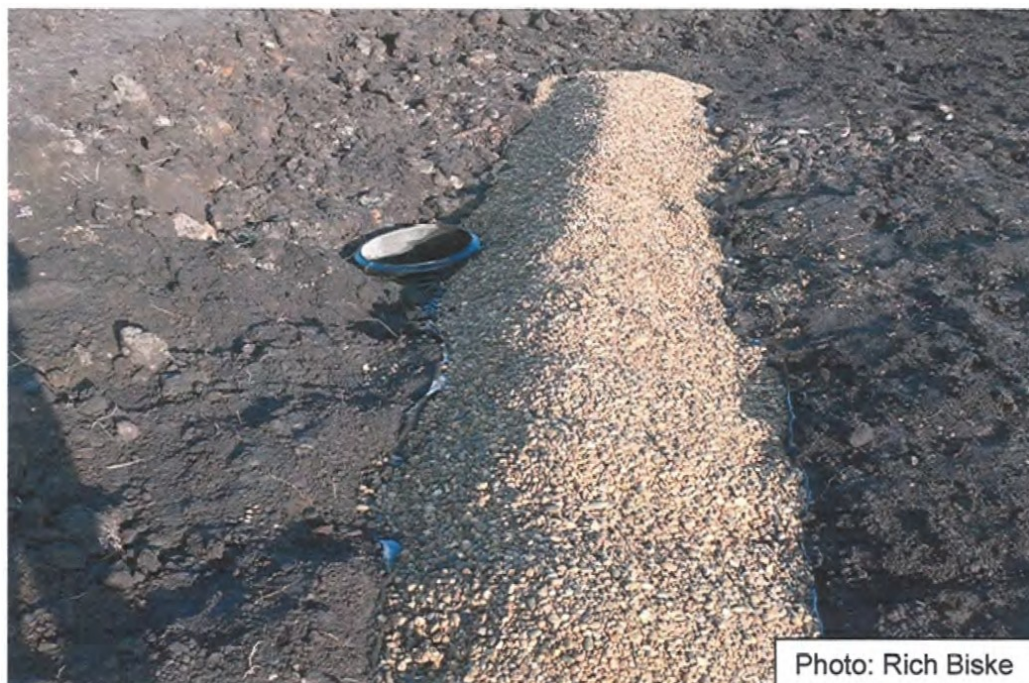
Figure 8. Top of modified side inlet showing rock lens.

A modified side inlet (Figure 7) was also installed to hold water on the edge of the field before entering the ditch, forcing water through a rock lens (Figure 8) that slows runoff and filters phosphorous laden sediment.

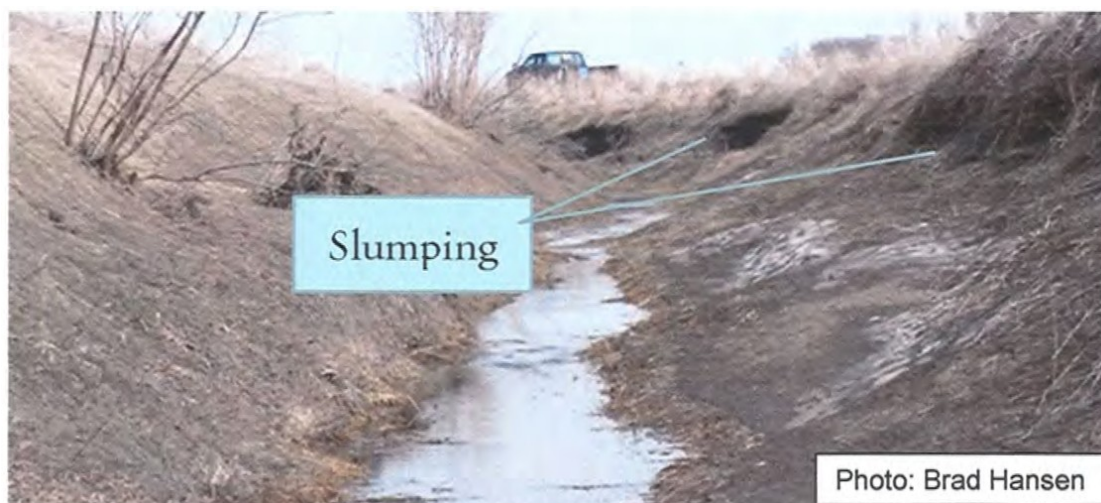
Figure 9. Portions of pre-construction ditch with slumping.

Another common situation with drainage ditch instability is bank slumping (Figure 9) due to seepage forces on the ditch bank. U of M and BWSR engineers designed a seepage trench (Figure 10) set back from the ditch bank to accumulate seepage water and direct it via tile line to a stable portion of the ditch bank.

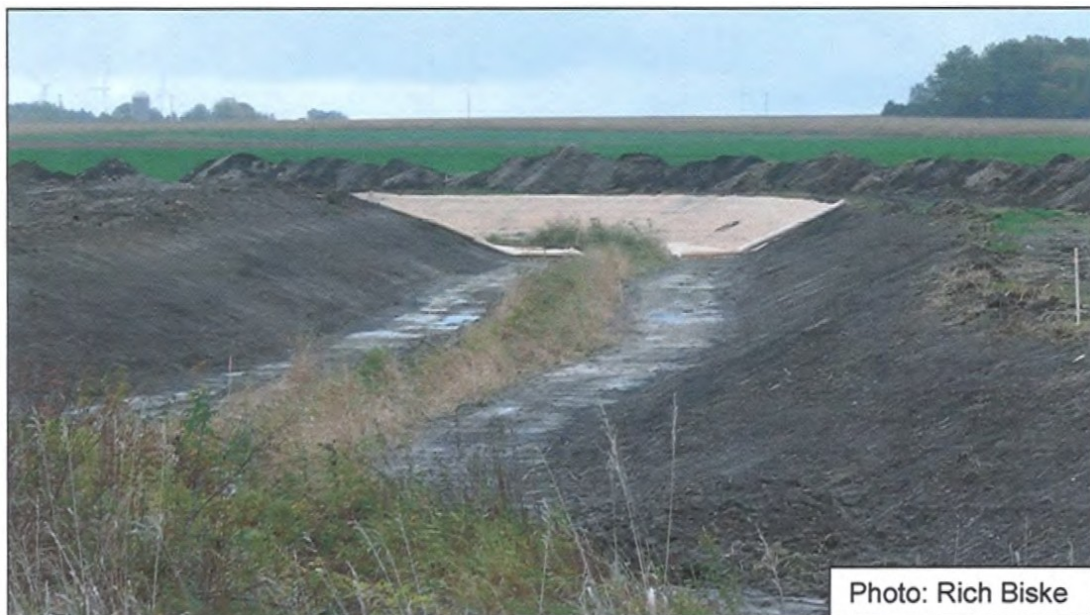
Figure 12. Excavated 2-Stage ditch showing vegetation in base flow channel

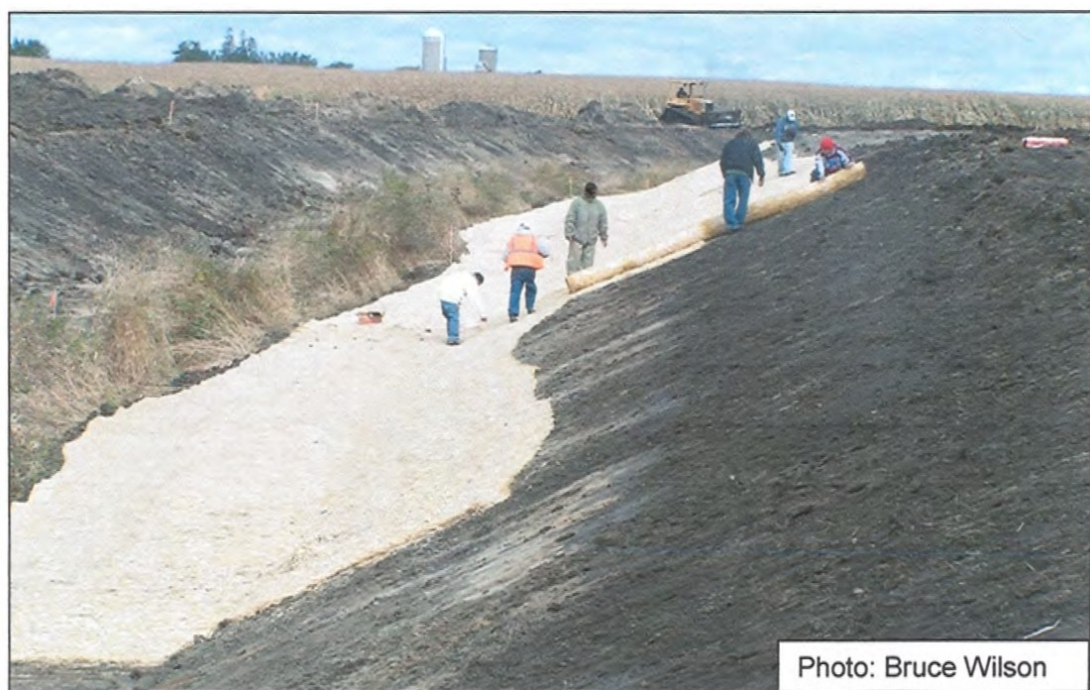
Figure 13. Placement of Erosion Control Blanket.

Due to various project delays the project was constructed after the growing season in 2009. It was a dormant seeding, but erosion control blanket was placed over the entire length of the ditch to minimize erosion. Because vegetation was not established some

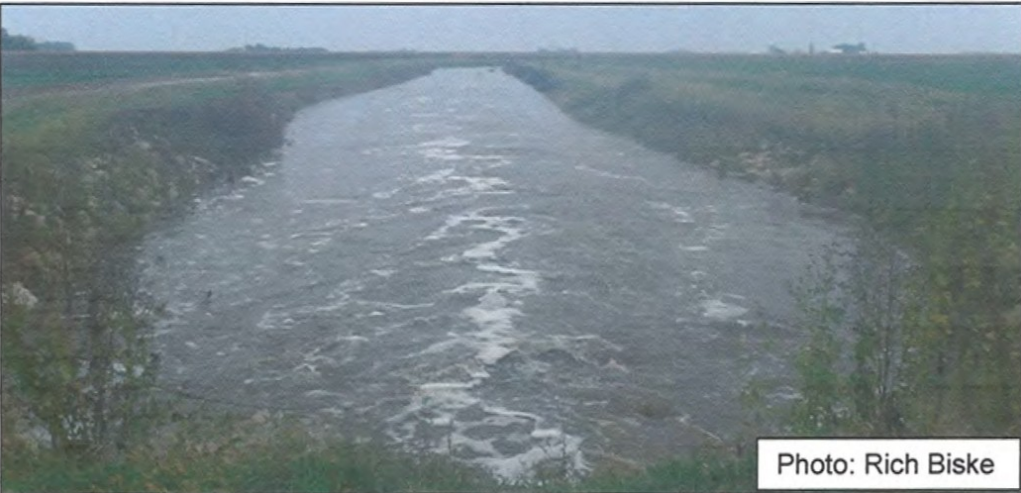
Figure 17. Upstream end during September 2010 flood event.

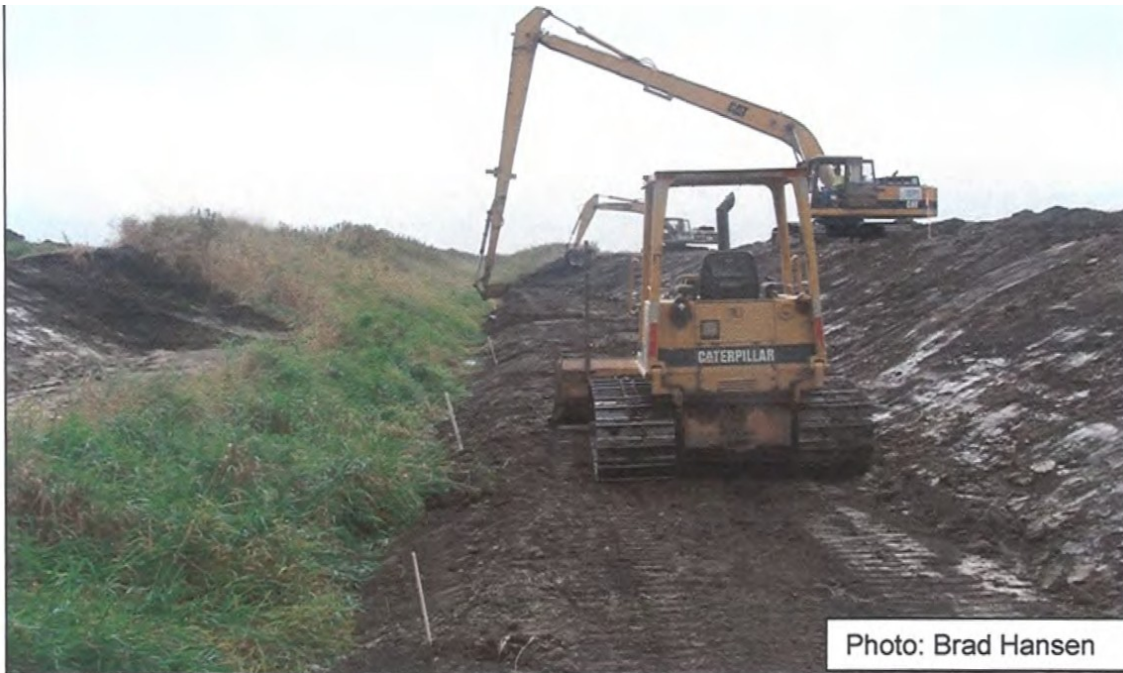
Figure 19. Stabilizing 2-stage ditch bench.

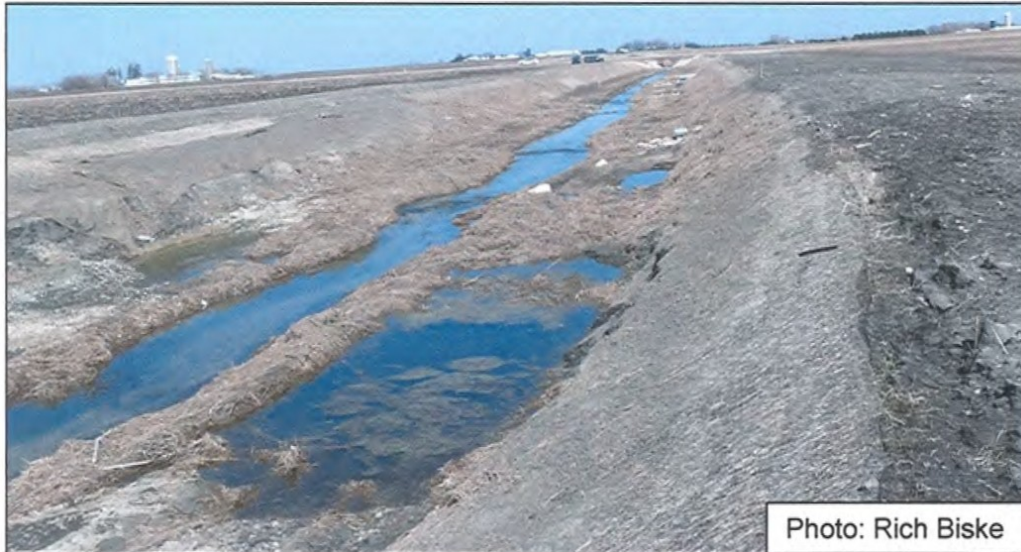
Figure 21. Bank failure on 2-stage ditch spring 2010.

- A bank failure occurred near the upstream end of the ditch (Figure 21).
  - It was determined the bank slumping was the result of an ice dam that gouged the ditch. Due to the late season construction and limited vegetation established, the banks were in a vulnerable position.

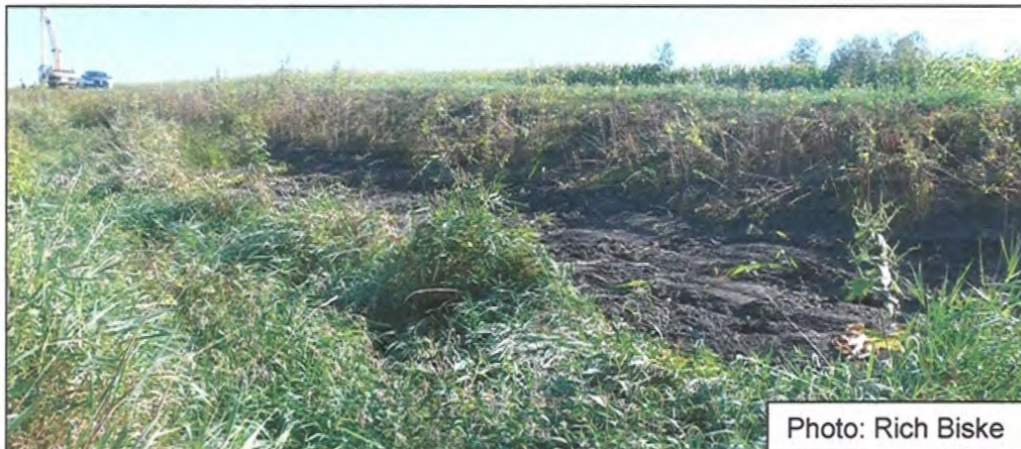
Figure 22. Repair of 2-stage ditch bank failure August 2010.

- Bank was rebuilt and stabilized to original design (Figure 22).
- Significant erosion had also taken place on the field side of side inlets.
  - This was the result of inadequate rip rap and poor seed establishment.

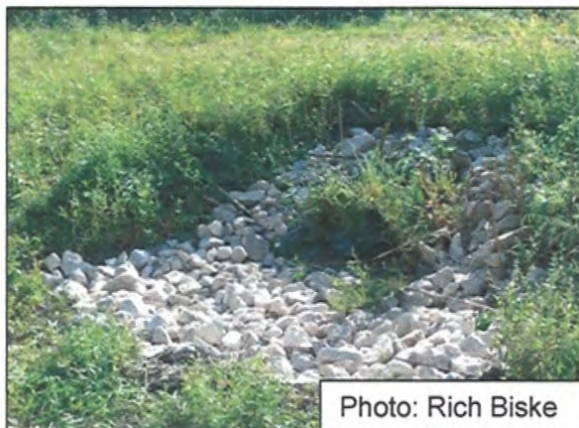
Figure 23. Rock inlet fixed with additional seeding and rip rap.

- More rip rap was placed and reseeded with erosion control blanket (Figure 23).
- Scour erosion had occurred at the outlet locations of side inlets and tile lines.

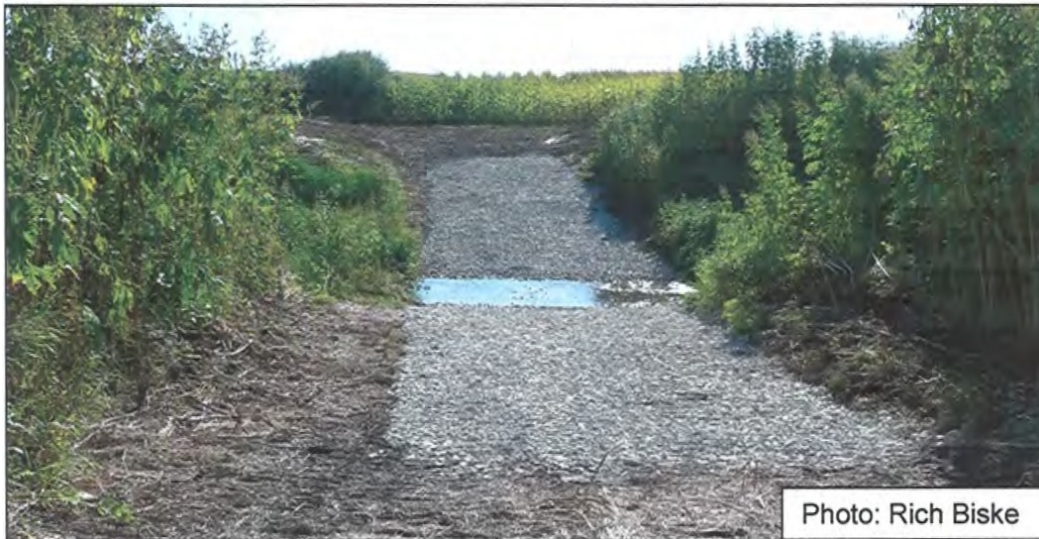
Figure 24. Missouri Crossing 2-Stage Ditch.

- There was no crossing within the new 2-stage ditch.
  - A Missouri crossing was installed where a previous crossing existed (Figure 24).

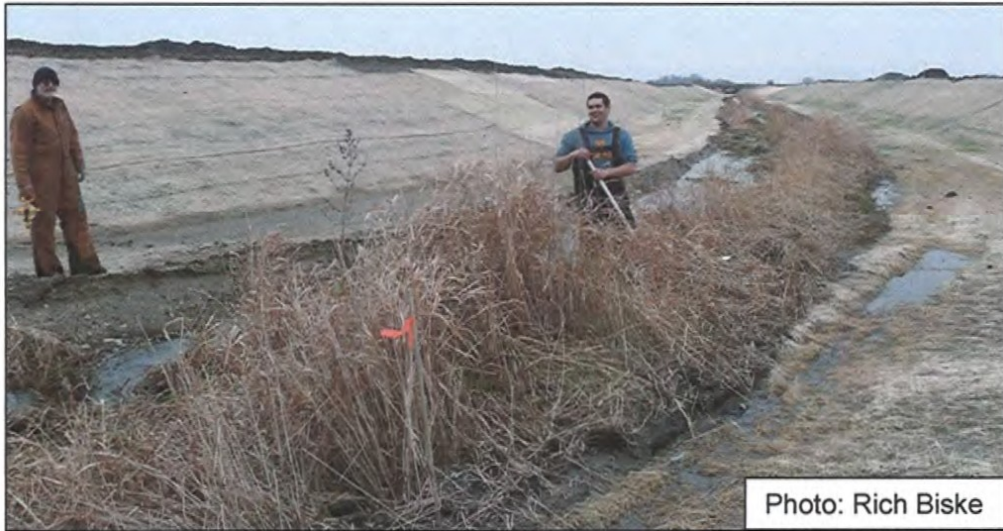
Figure 26. Installation of monitoring wells to measure seepage forces.

Bank and channel stability will be assessed using a combination of Rosgen's stability index and Simon channel evolution stage models as well as measurements of bank parameters bulk density, shear stress and moisture content (Figure 26).

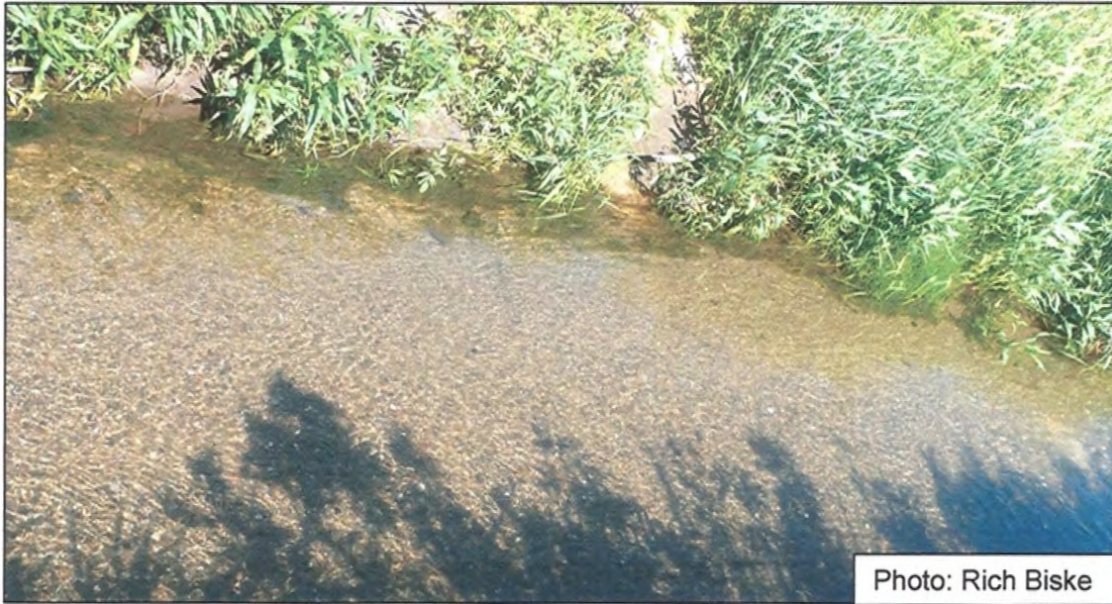
Figure 28. Cobble ditch bed a sign of good aquatic habitat.

Standard methods were used to obtain IBI scores for the drainage ditch and appropriate reference reaches prior to and after the construction of alternative designs. Fish and macroinvertebrate monitoring took place pre and post construction by Minnesota Pollution Control Agency staff. This data will be analyzed in the winter of 2010/2011. This is a good indication of habitat within the treatment reach (Figure 28).

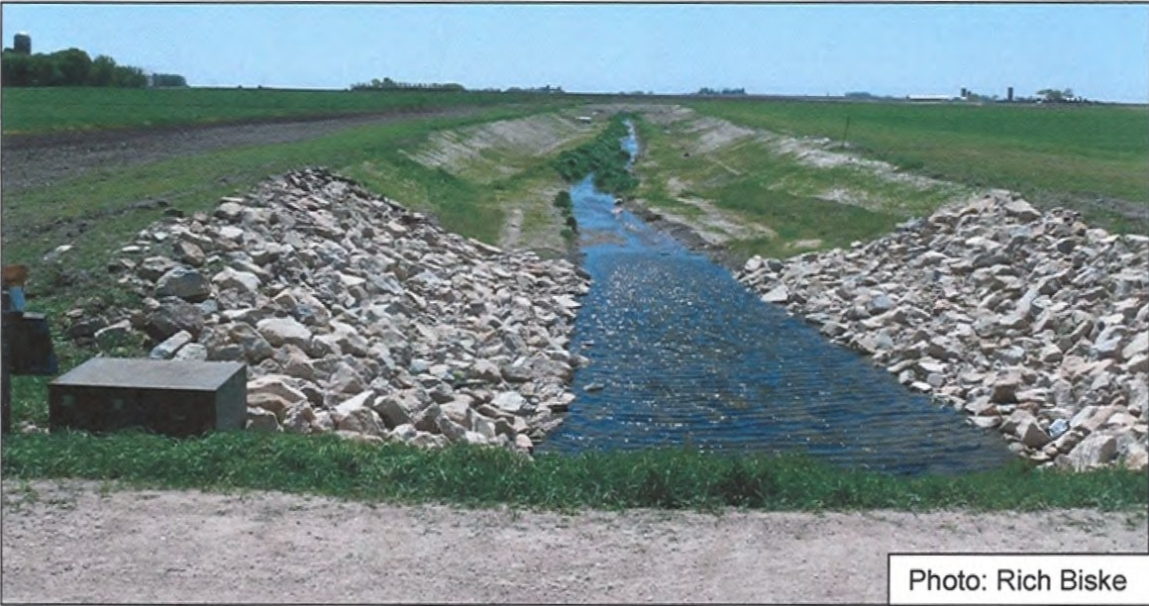
Figure 32. Monitoring station at upstream end of ditch.

- Intensive nitrogen monitoring
  - o One week – cool and warm
  - o Detailed inflow (Figure 32) and outflow (Figure 33) measurements
  - o Use nitrate probe
- Automatic sampling probes
  - o Turbidity
  - o pH,
  - o Temperature

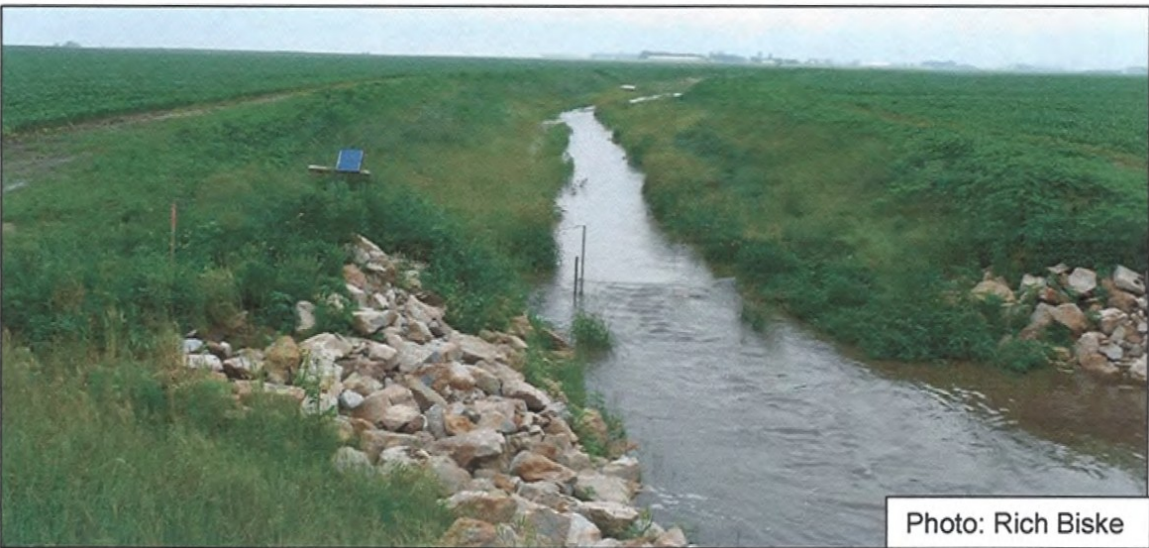
Figure 33. Monitoring station at downstream end.
