Beaver Stadium: A Decision Case in Football Field Management

ABSTRACT

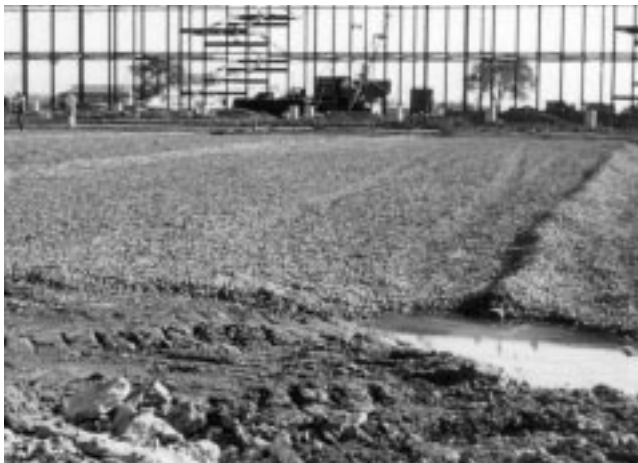
Personnel from Penn State's Office of Physical Plant oversaw the construction of the football field at Beaver Stadium by an outside contractor in 1959. After excavating down to the subsoil, a coarse gravel blanket 15 cm thick was installed containing drain tiles spaced 1.8 m apart (Fig. 1). A 45- to 53-cm layer of silt loam soil was placed on top of the gravel, fine graded, fertilized, and limed in preparation for sodding (Harper, 1969). Strips of 'Merion' Kentucky bluegrass (*Poa pratensis* L.) sod measuring 45 by 180 cm were planted. Additional soil was worked into the cracks separating sod strips to minimize the potential for desiccation at the edges. An irrigation program was initiated to promote rooting and sustain shoot growth. By the time the new turf was fully established, however, a serious internal drainage problem was evident (Fig. 2). The field would remain saturated for extended periods and water would stand in depressed areas along the sidelines after each rain.

Fig. 1. Installation of gravel blanket during construction in 1959.

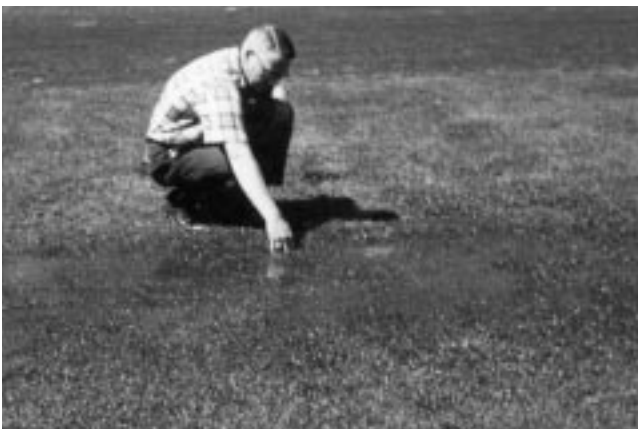
Fig. 2. Surface water along sideline, indicating poor internal drainage in 1960.

In 1960 a portion of the sod was removed, additional soil was added, and the sod was replaced, to provide a 25-cm crown down the center of the field. Catch basins were added to carry standing water along the sidelines to drain pipes located in the gravel layer. These changes were made to accelerate surface drainage and subsequent removal of

standing water. While these measures did not provide an entirely satisfactory solution to the internal drainage problem, they did reduce its severity.

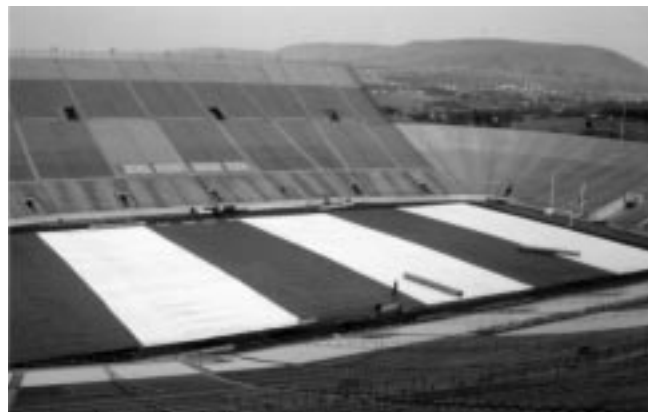
Field maintenance included measures to carefully manage the amount of water entering the turf. This involved the installation of canvas tarps on the field whenever rainfall was expected for several days preceding a game or practice session (Fig. 3). The tarps were stored in large rolls along the sides of the field for easy access. The full- and part-time members of the maintenance crew—working at the stadium or involved in maintenance operations at any of the numerous practice and playing fields under the control of the Athletic Department—were the personnel needed to pull the tarps in place. Also, since the primary avenue by which water left the soil after infiltration was through evapotranspiration (Kneebone et al., 1992), irrigation was carefully monitored and controlled to limit the amount of water infiltrating the turf. A large travelling sprinkler with an adjustable speed control was used for irrigation. Based on the amount of moisture in the soil, the control was adjusted to set the speed at which the sprinkler traveled across the field. Given the flow rate of water through the nozzles of the sprinkler, controlling the sprinkler's rate of movement across the field controlled the amount of water applied to the turf. Through the combination of tarping and irrigation management, the turf's moisture requirements were met and a firm playing surface was maintained during the playing season.

Fig. 3. Grounds-crew members installing canvas tarps on the field in anticipation of rainfall.
